“Keith Funnell” Contours

General

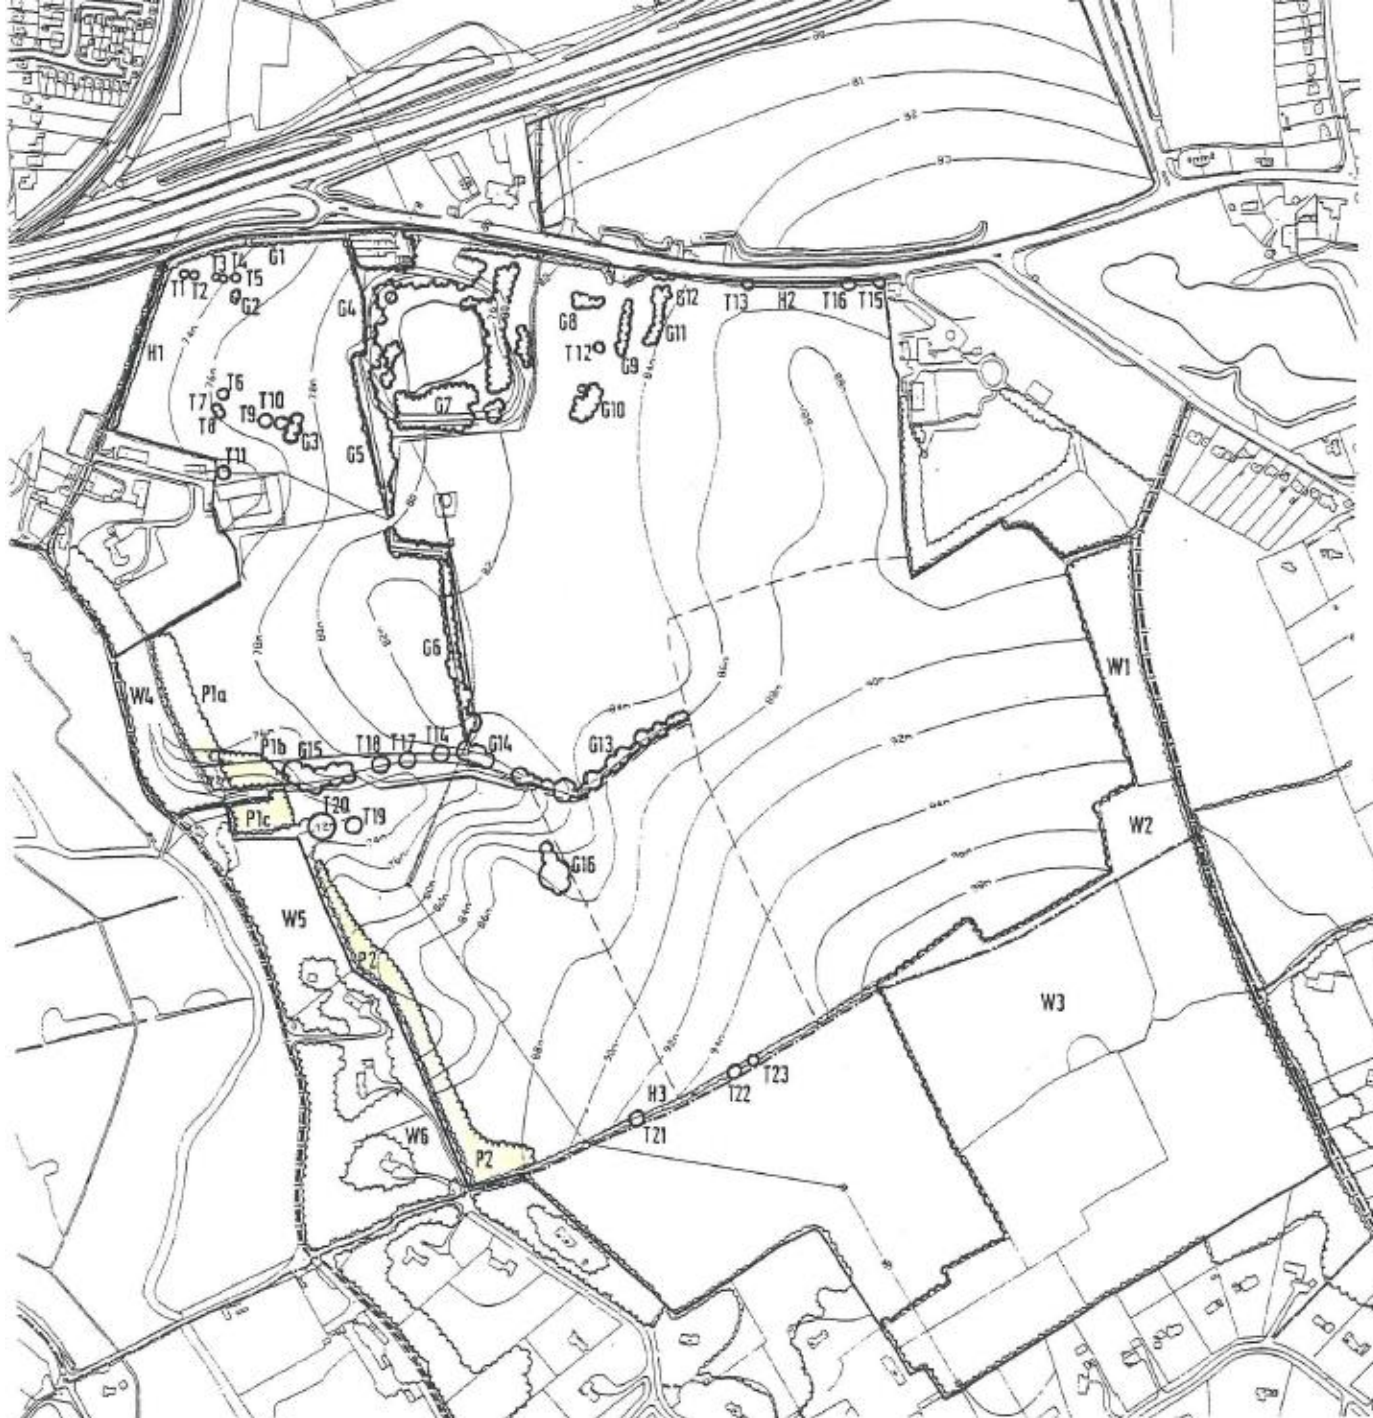
The topographic map illustrates the terrain of a construction site with contour lines indicating elevation. The map is divided into several labeled areas: AREA A, AREA B, AREA C, AREA D, and AREA E. Key features include a 'Waste Station' in the upper left, a 'Stockpile' in the center, and a 'Clay Stockpile' in the lower left. A 'Gravel Stockpile' is located near the center, and a 'Tree Plantation Area' is shown in the lower right. Elevation markers range from 70m to 98m. The map also shows various construction elements like roads, buildings, and vegetation. A grid is overlaid on the map, and an 'Average Tree Ht. 13.00m' is noted in the lower right.

- Need to ensure that the existing contours are logged correctly, including the unworked areas around the site.
- Where historic mixed waste landfill areas have been overfilled need to look to mitigate the visual impact, without re-opening the landfills.

- Need to ensure that the “fields” that are created will support long term sustainable after care.
- Need to ensure that mature trees on the site are protected during all phases, including current operation phase

- Stockpiling of all materials needs to be permitted and managed appropriately, taking account of the previous landfilling on the site and the impact of increasing the overburden in these areas.

- Future filling at the site should be done to create contours that tie into the surrounding unworked areas, support an appropriate Surface Water Management Plan and create areas which can be subject to sustainable aftercare.

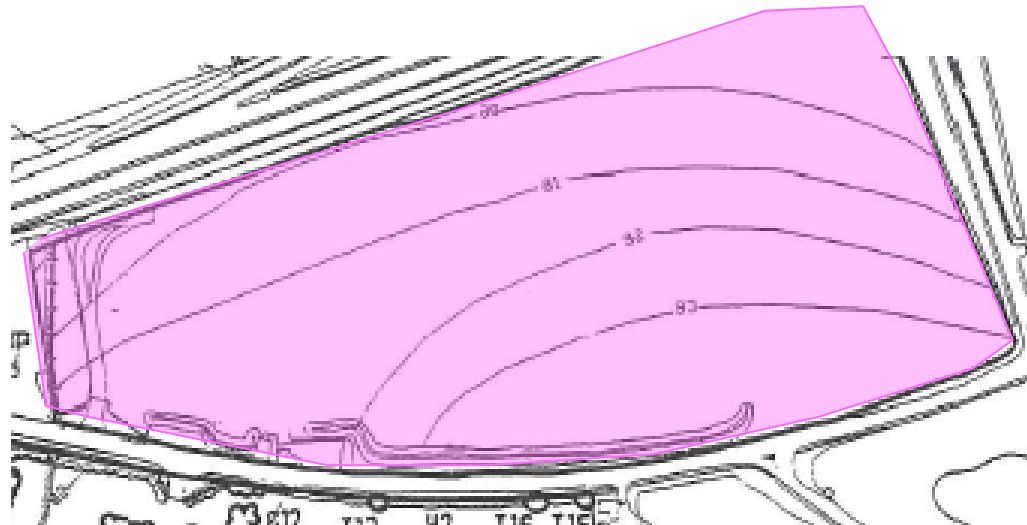
North Runfold

The Community believes that this area has been significantly overfilled resulting in the loss of visual amenity from the surrounding roads and that the contours will not settle to those permitted. Instead of a gentle slope, a table top with very steep sides has been created.

This is a mixed waste landfill and therefore the Community understands that the environmental impacts of reducing the levels would be significant. The Community therefore support maintaining the current levels (with any further reduction that occurs naturally) and mitigating the visual impact.

The Community would like to very steep edges of this area to be redressed where possible and planted as appropriate to stabilise the area, screen the slope and create appropriate nature barriers to support grazing.

In order to support this area being placed into sustainable aftercare as soon as possible the Community would support the temporary use of electric fencing whilst the hedgerows are being established.

The Community would like a clear plan showing the retained infrastructure, including the associated monitoring facilities.

As restoration in this area has previously failed the Community would like a detailed review of the causes of the failure and the development of revised restoration plan to support the concerns above and the causes of previous failed restoration.
